TESTS OF REINFORCED CONCRETE FLAT SLAB STRUCTURES

BY
ARTHUR N. TALBOT
And
WILLIS A. SLATER

BULLETIN No. 84
ENGINEERING EXPERIMENT STATION

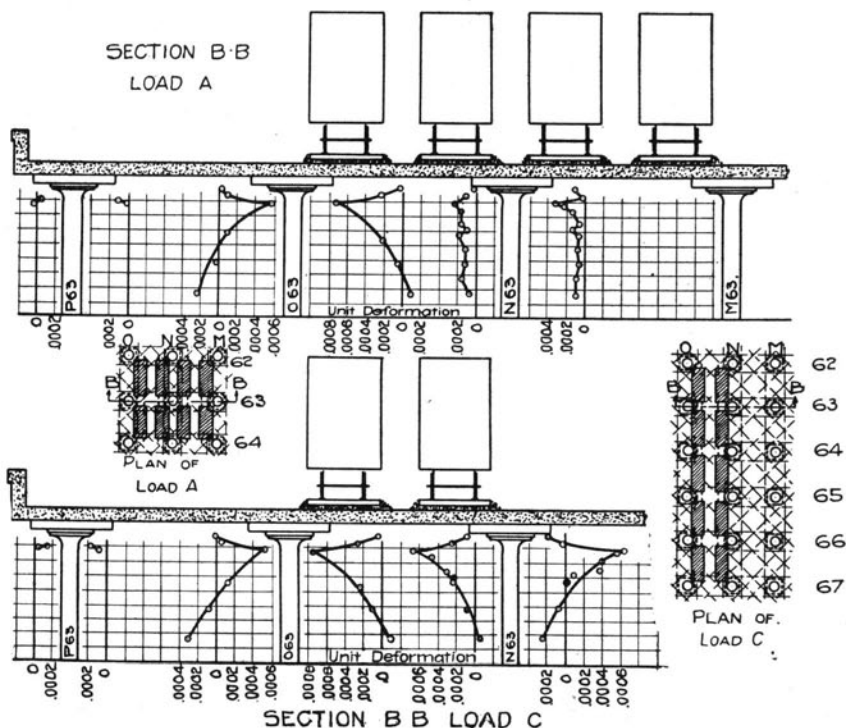
FIG. 38. DEFORMATION IN COLUMNS CUT BY SECTION B-B (NORMAL TO TRACKS) OF SOO TERMINAL STRUCTURE.

higher and more definite than the stresses in the slab. The amount of the deformations in the concrete on opposite sides of the column is shown graphically in Fig. 37 to 41. The large tensile deformations in the columns show that the reinforcing bars were subjected to considerable tensile stress, and even considering the compression due to dead load the tensile strength of the concrete must have been exceeded. This action is also shown by the formation of cracks on the tension side of the columns. Measurements made on the reinforcing bars (not plotted in the figures) show tensile deformations smaller than those observed in the concrete, but still considerable. The distribution of the flexural deformations along the column length is also shown in Fig. 37 to 41. In general the point of zero deformation is lower on the compression side than on the tension side of the column, a difference which may be due in part to the direct compression caused by the test load. Table 4 gives the distances from the bottom of the depressed head to the point of zero deformation on the two sides of their columns and their averages. The distances are

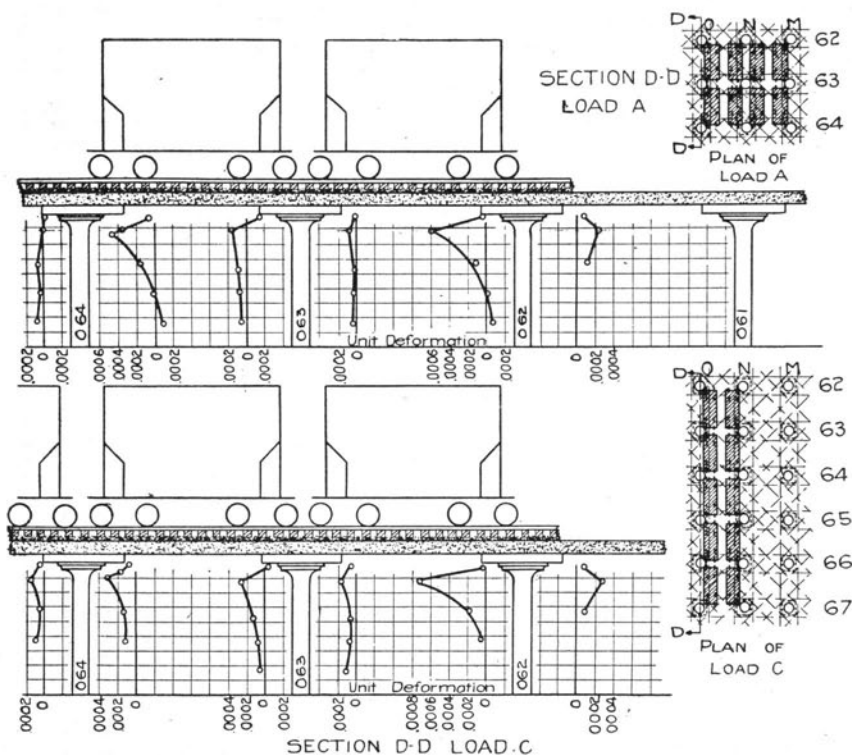
FIG. 40. DEFORMATION IN COLUMNS CUT BY SECTION D-D (PARALLEL TO TRACKS) OF SOO TERMINAL STRUCTURE.

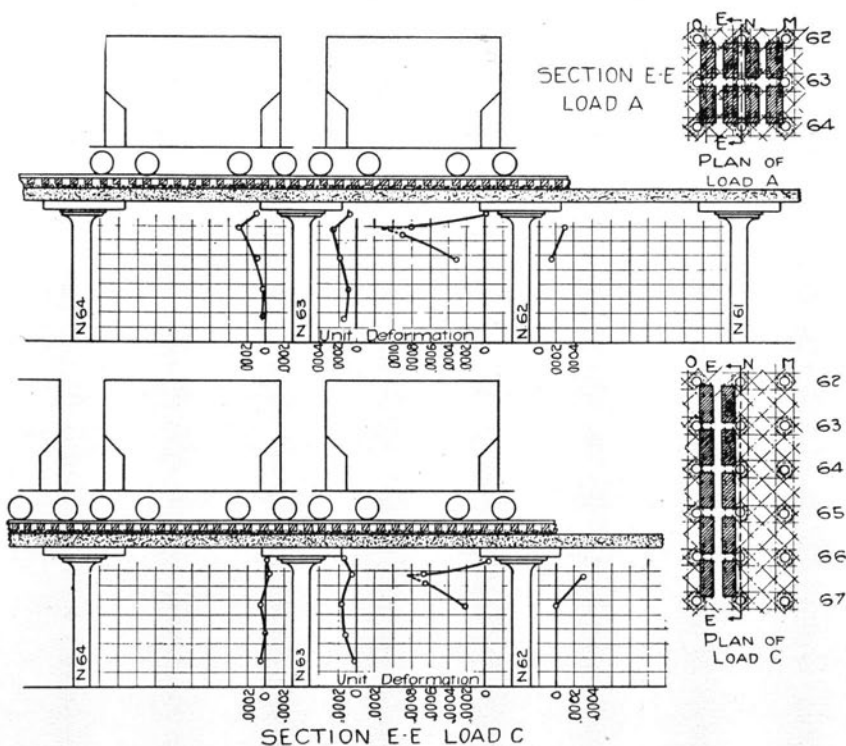
FIG. 41. DEFORMATION IN COLUMNS CUT BY SECTION E-E (PARALLEL TO TRACKS) OF SOO TERMINAL STRUCTURE.

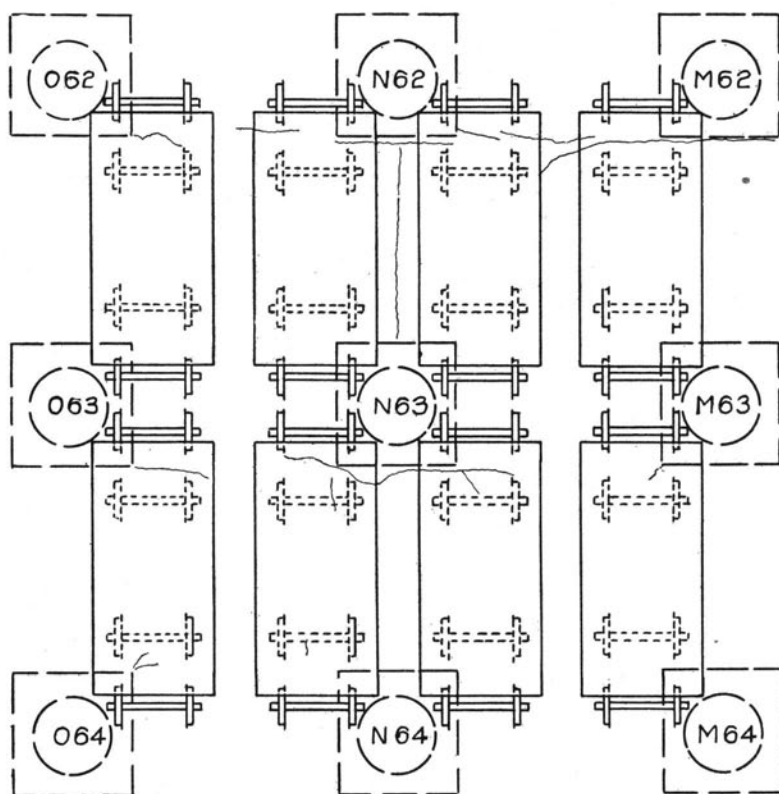
FIG. 42. LOCATION OF CRACKS IN SOO TERMINAL TEST FLOOR.

in the slab when the four-panel load (load A) was in position is shown in Fig. 42. All these cracks were found on the bottom of the slab. No cracks were found on the top. It is seen that in general they extend in a direction parallel with the rows of columns, displaying also a slight tendency to extend along the diagonal of the panel. Portions of the upper side of the slab were covered with ballast and no examination for cracks could be made in these places, but as the ballasted regions occupied the central portions of the panels where compression should be found cracks would not be expected at these places. The top of the slab was available for examination over all columns, and no cracks could be found in such positions although a careful search for them was made. It is seen that the cracks referred to are in regions where compression would be expected. Their appearance may be explained by even a slight settlement of columns; those on the under side of the slab close to the depressed heads of some of the columns at the edge of

the loaded area may be explained if there were settlement of these columns, and those which were found on the under side of the slab close to the depressed head of the central column if there were a settlement of this column larger than that of any other.

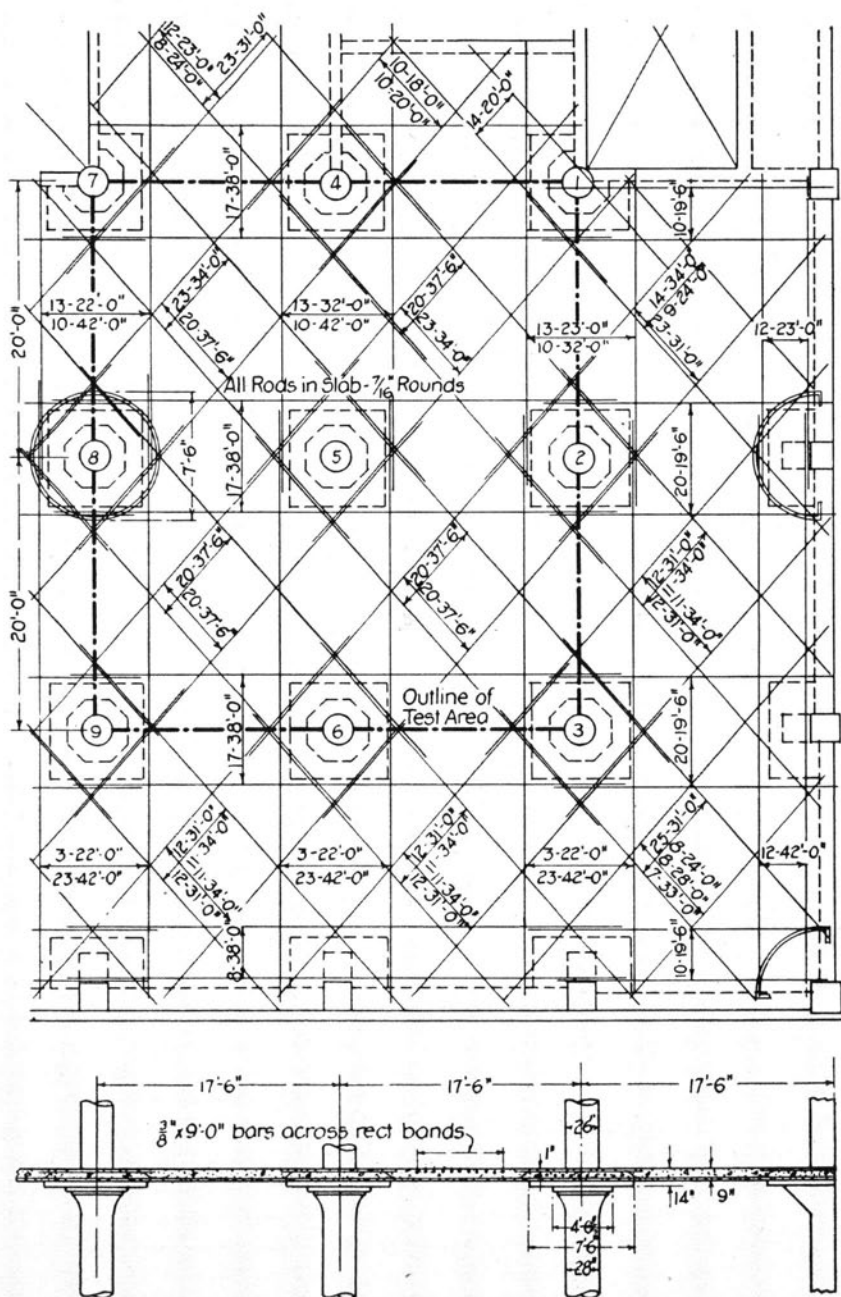
FIG. 43. DIMENSIONS AND REINFORCEMENT PLANS OF TEST FLOOR OF SCHULZE BAKING COMPANY BUILDING.

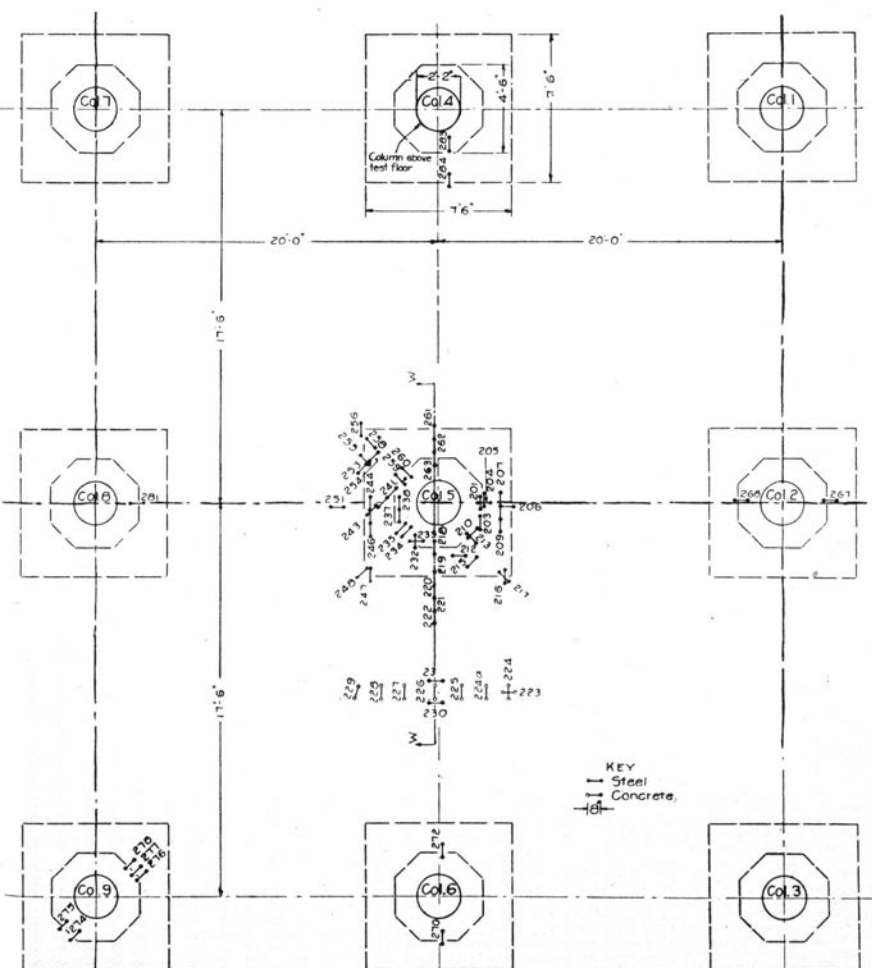
FIG. 44. GAGE LINES ON UPPER SURFACE OF TEST FLOOR OF SCHULZE BAKING COMPANY BUILDING.

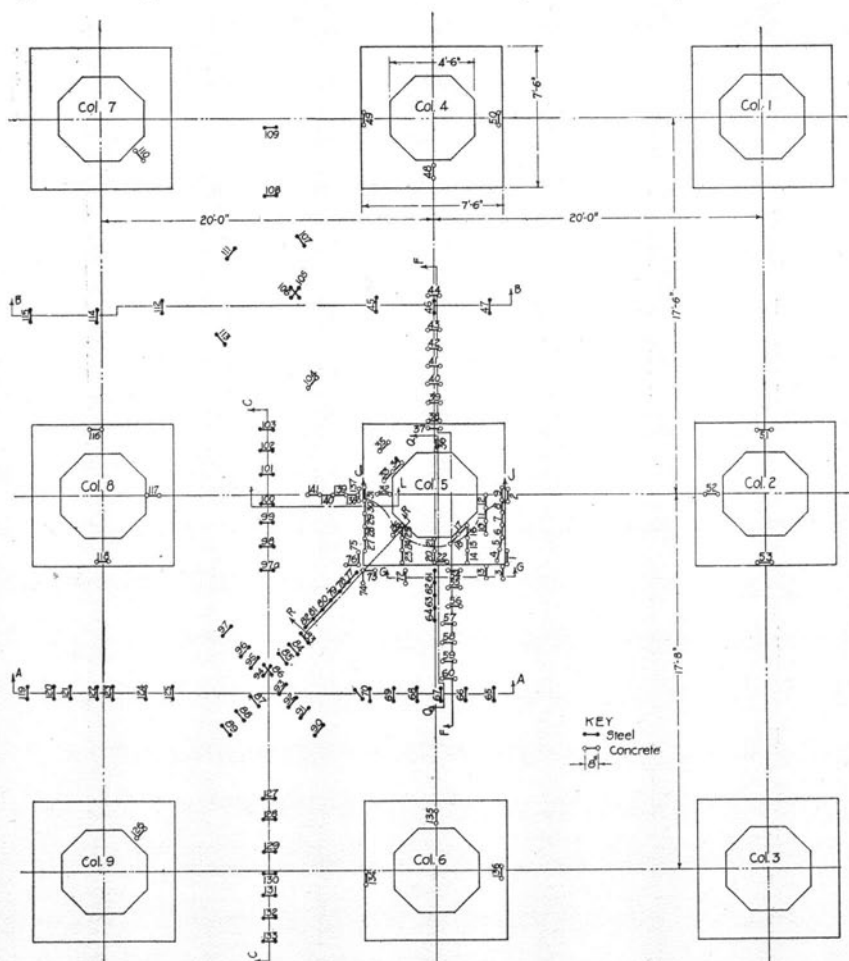
FIG. 45. GAGE LINES ON UNDER SURFACE OF TEST FLOOR OF SCHULZE BAKING COMPANY BUILDING.

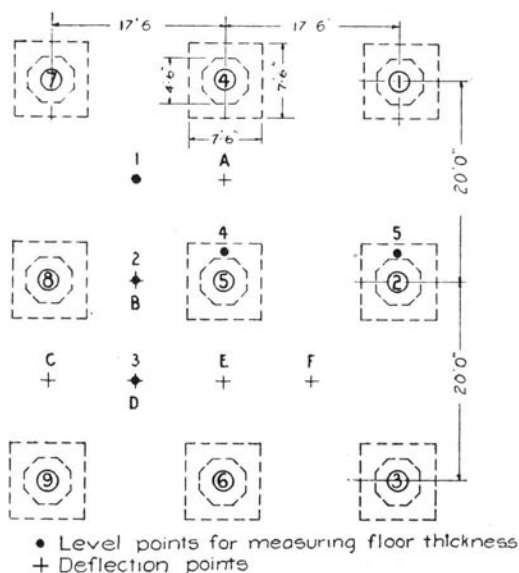
FIG. 46. LOCATION OF POINTS FOR MEASUREMENT OF THICKNESS AND OF DEFLECTION OF TEST FLOOR IN SCHULZE BAKING COMPANY BUILDING.

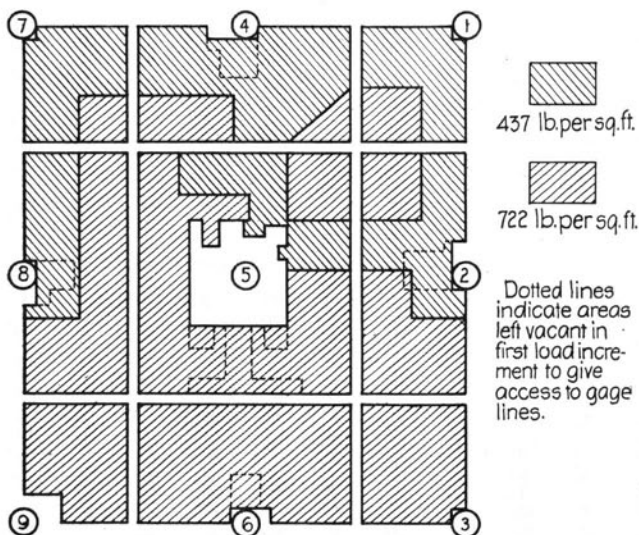
FIG. 47. PLAN SHOWING DISTRIBUTION OF LOAD ON TEST FLOOR OF SCHULZE BAKING COMPANY BUILDING.

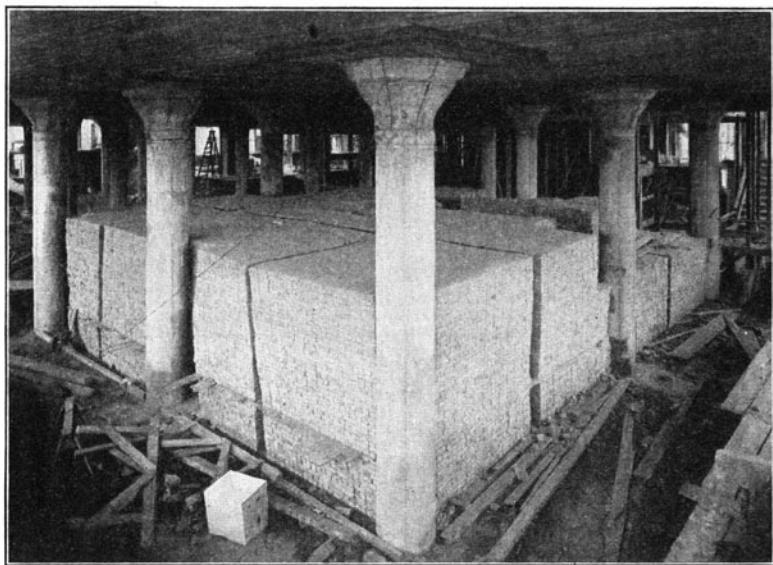
FIG. 48. VIEW OF TEST LOAD ON FLOOR OF SCHULZE BAKING COMPANY BUILDING.

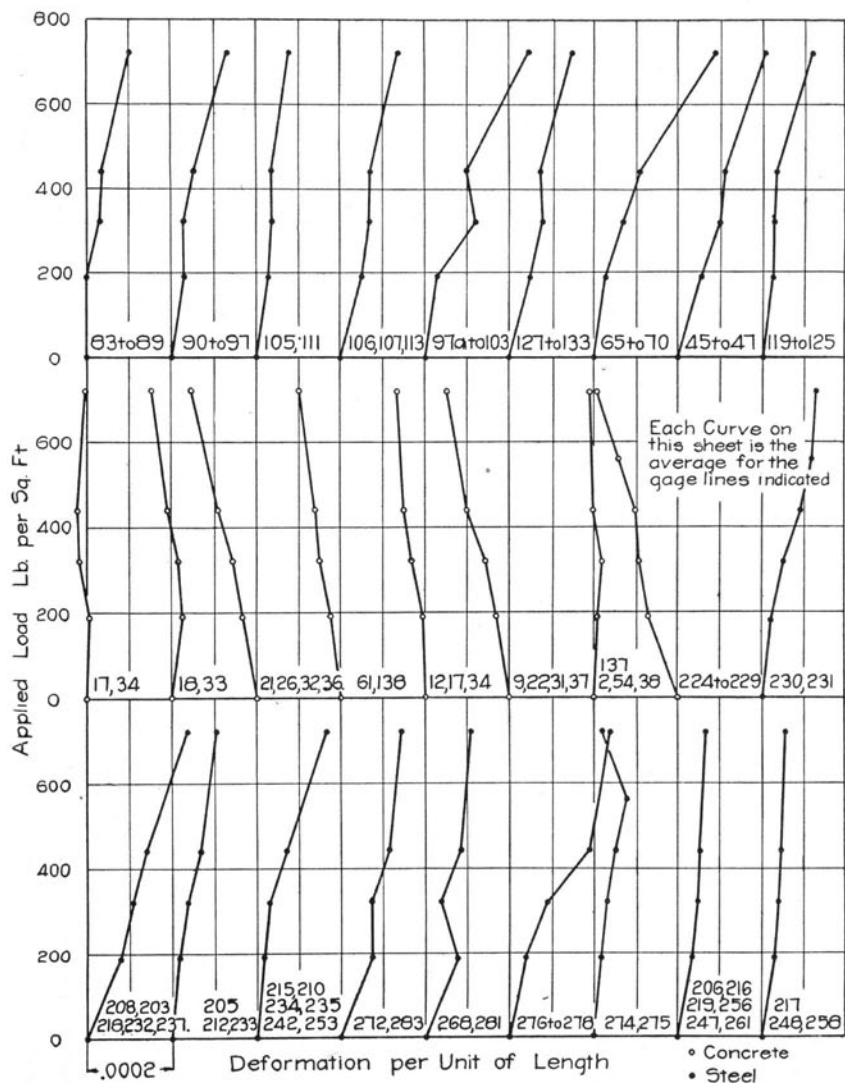
FIG. 49. AVERAGE LOAD-DEFORMATION DIAGRAM FOR TEST IN SCHULZE BAKING COMPANY BUILDING.

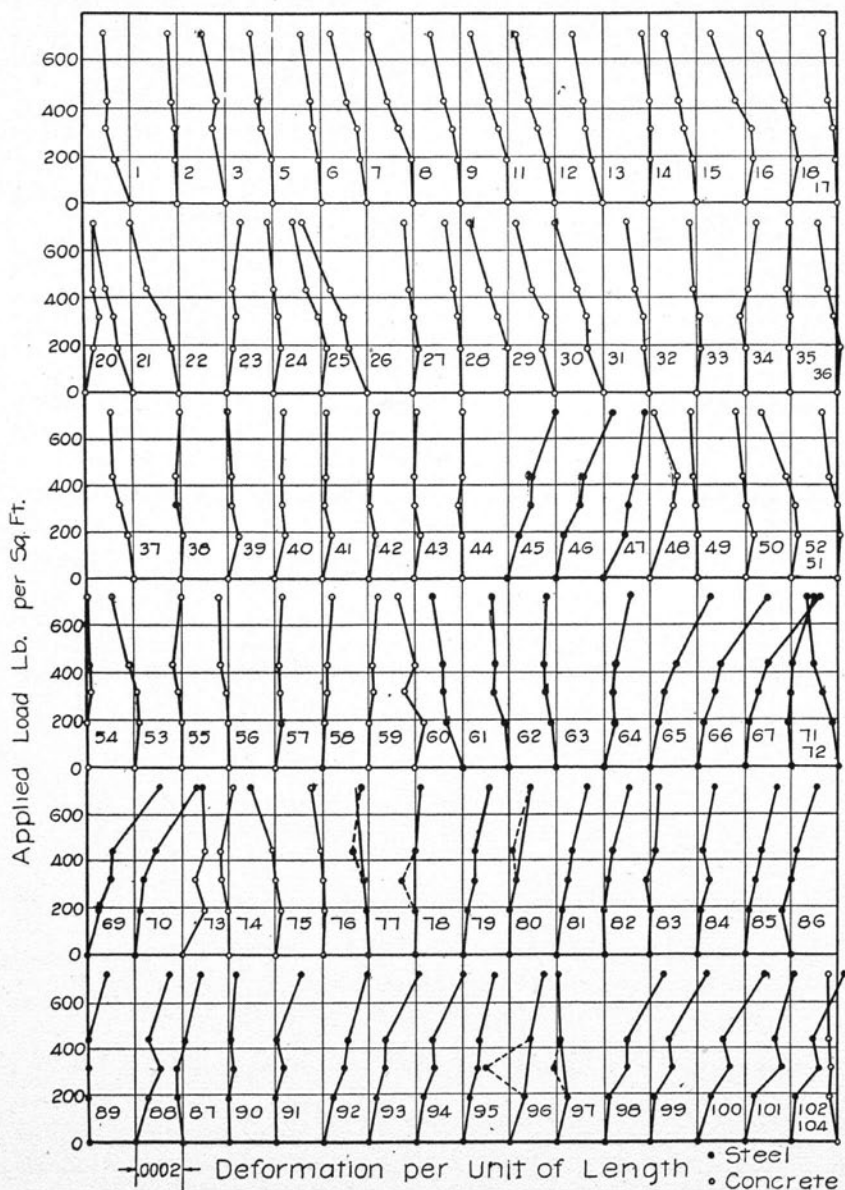
FIG. 50. LOAD-DEFORMATION DIAGRAMS FOR GAGE LINES 1 TO 102 OF TEST IN SCHULZE BAKING COMPANY BUILDING.

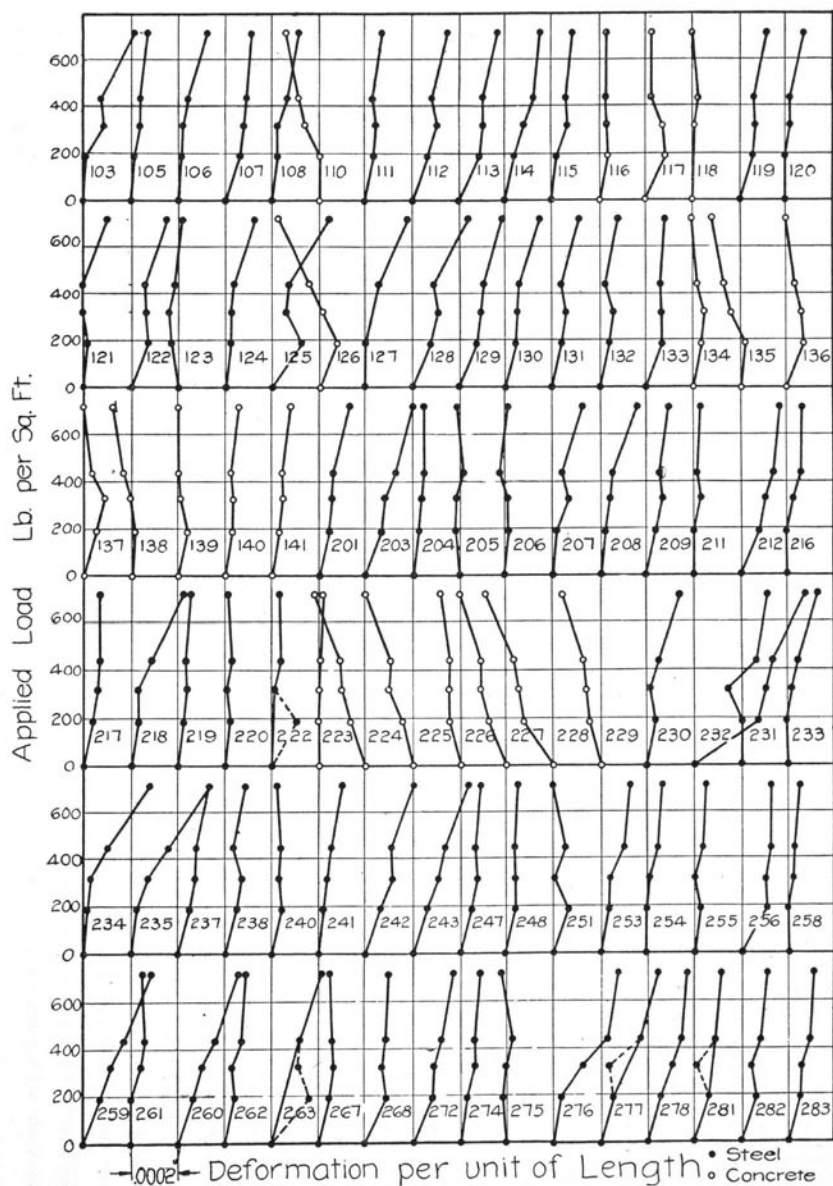
FIG. 51. LOAD-DEFORMATION DIAGRAMS FOR GAGE LINES 100 TO 283 OF TEST IN SCHULZE BAKING COMPANY BUILDING.

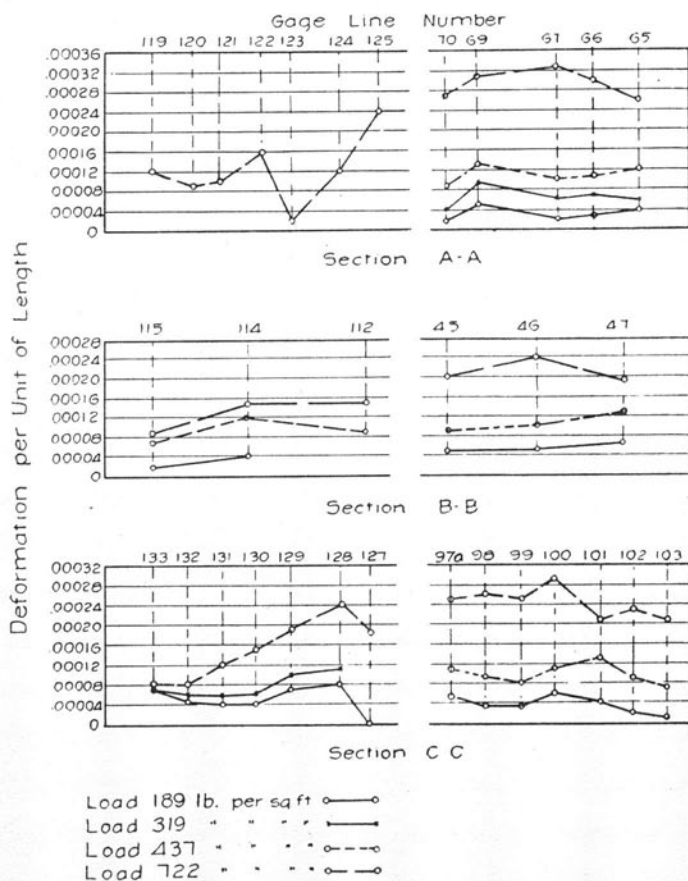
FIG. 52. DEFORMATION IN REINFORCEMENT IN RECTANGULAR BANDS MIDWAY BETWEEN COLUMNS IN TEST FLOOR OF SCHULZE BAKING COMPANY BUILDING.

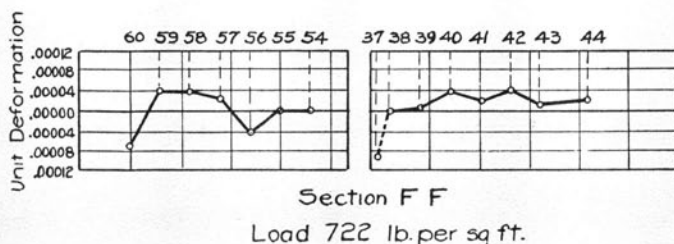
FIG. 53. LATERAL DISTRIBUTION OF COMPRESSIVE DEFORMATION ON BOTTOM OF TEST FLOOR NEAR DEPRESSED HEAD IN SCHULZE BAKING COMPANY BUILDING.

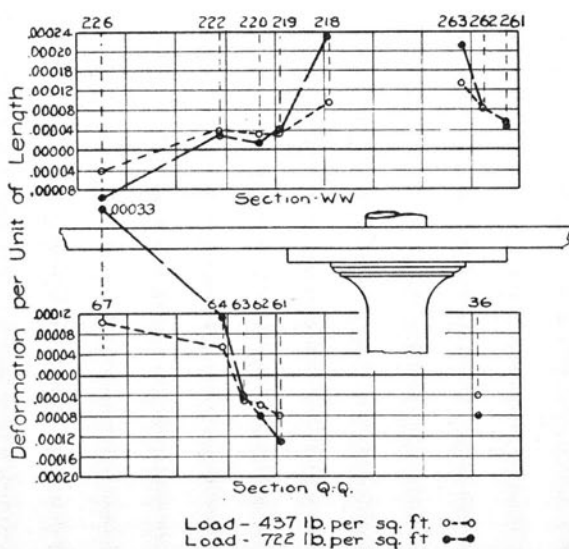
FIG. 55. LOCATION OF POINTS OF ZERO UNIT-DEFORMATION ON UPPER AND UNDER SURFACES OF TEST FLOOR OF SCHULZE BAKING COMPANY BUILDING.

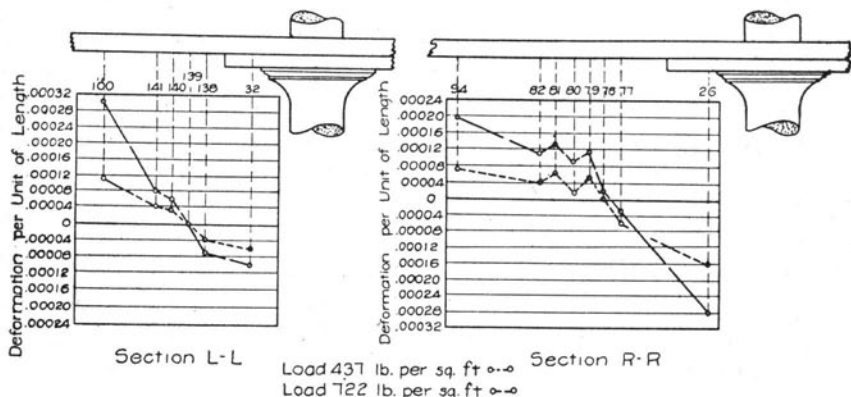
FIG. 56. LOCATION OF POINTS OF ZERO UNIT-DEFORMATION ON UNDER SURFACE OF TEST FLOOR OF SCHULTZE BAKING COMPANY BUILDING.

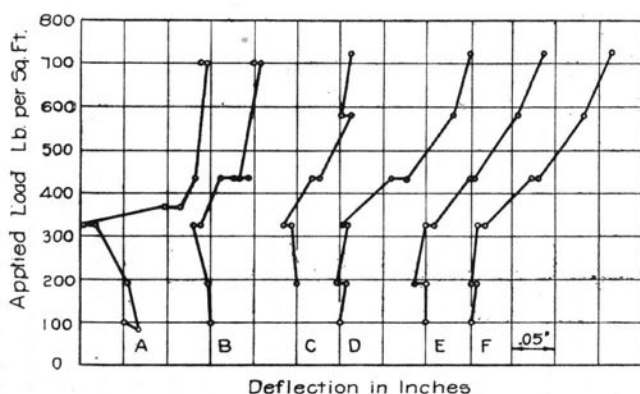
FIG. 57. LOAD-DEFLECTION DIAGRAMS FOR FLOOR TEST IN SCHULZE BAKING COMPANY BUILDING.

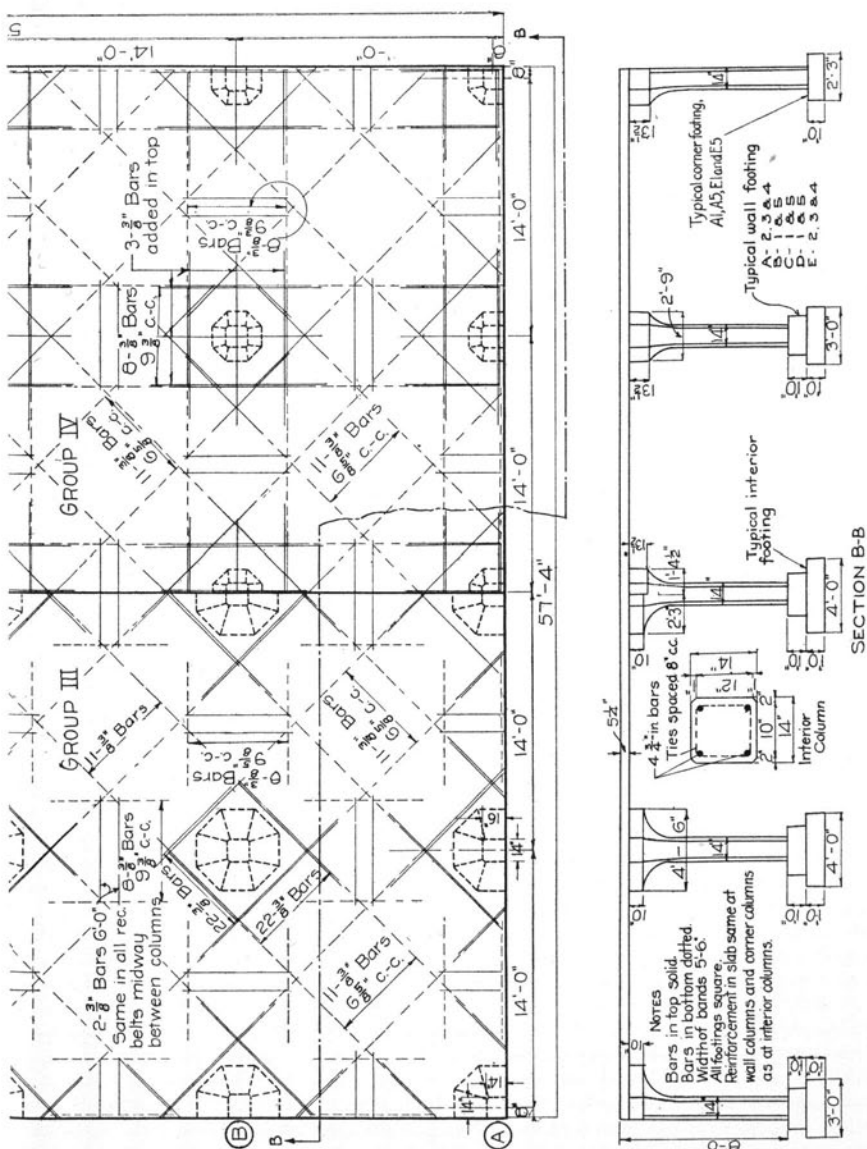
PLAN FOR WORCESTER TEST FLOOR.

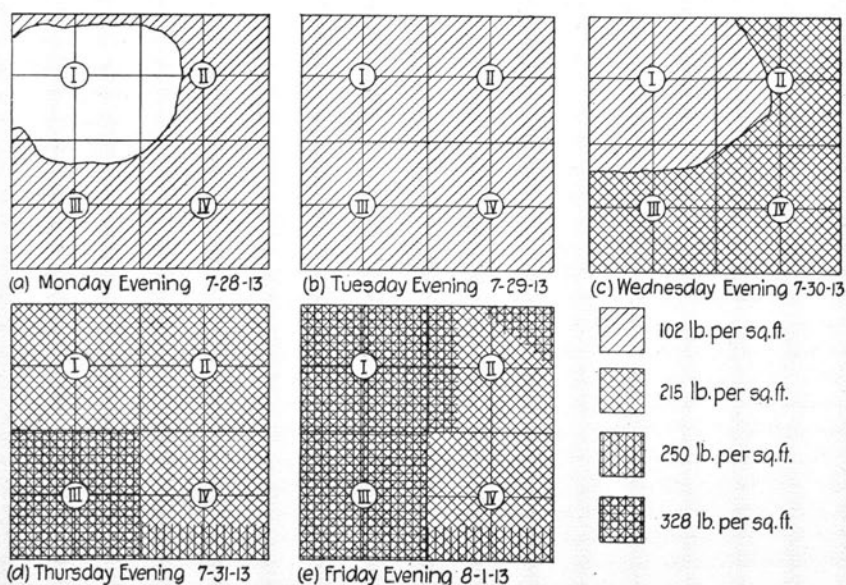
FIG. 59. PLAN SHOWING DISTRIBUTION OF LOAD OVER WORCESTER TEST FLOOR AT SUCCESSIVE STAGES OF THE TEST.

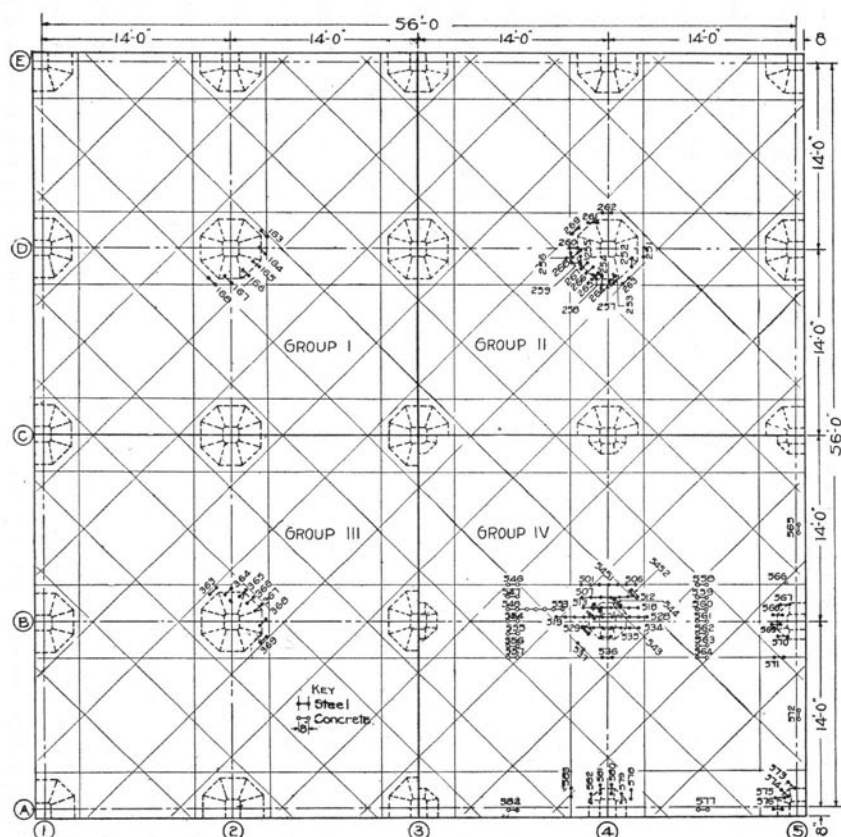
FIG. 60. LOCATION OF GAGE LINES ON UPPER SURFACE OF WORCESTER TEST FLOOR.

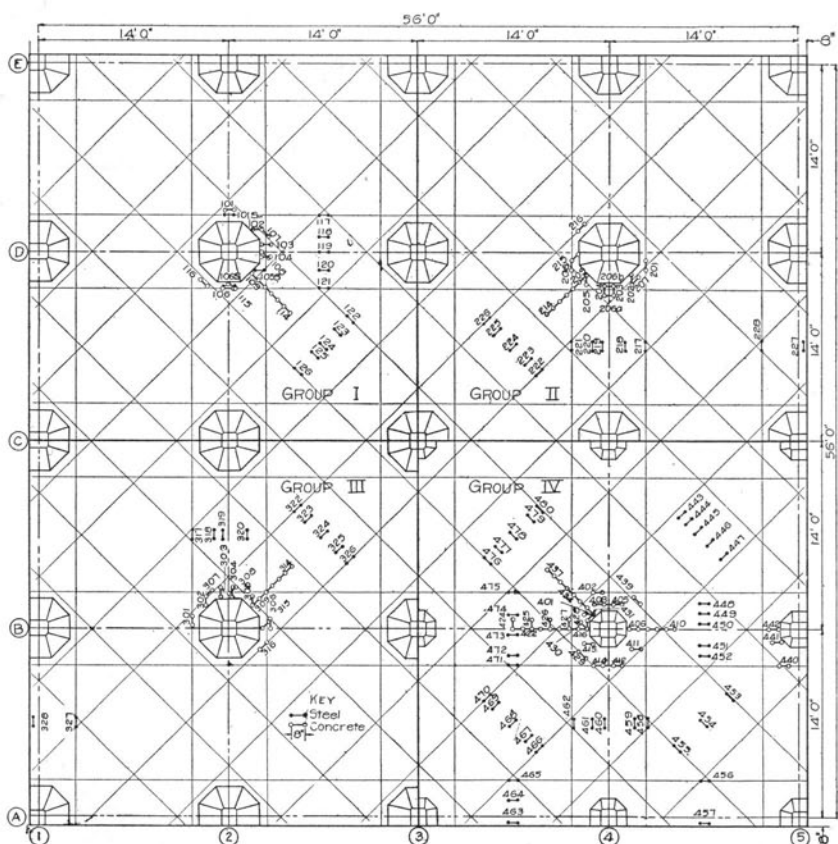
FIG. 61. LOCATION OF GAGE LINES ON UNDER SURFACE OF WORCESTER TEST FLOOR.

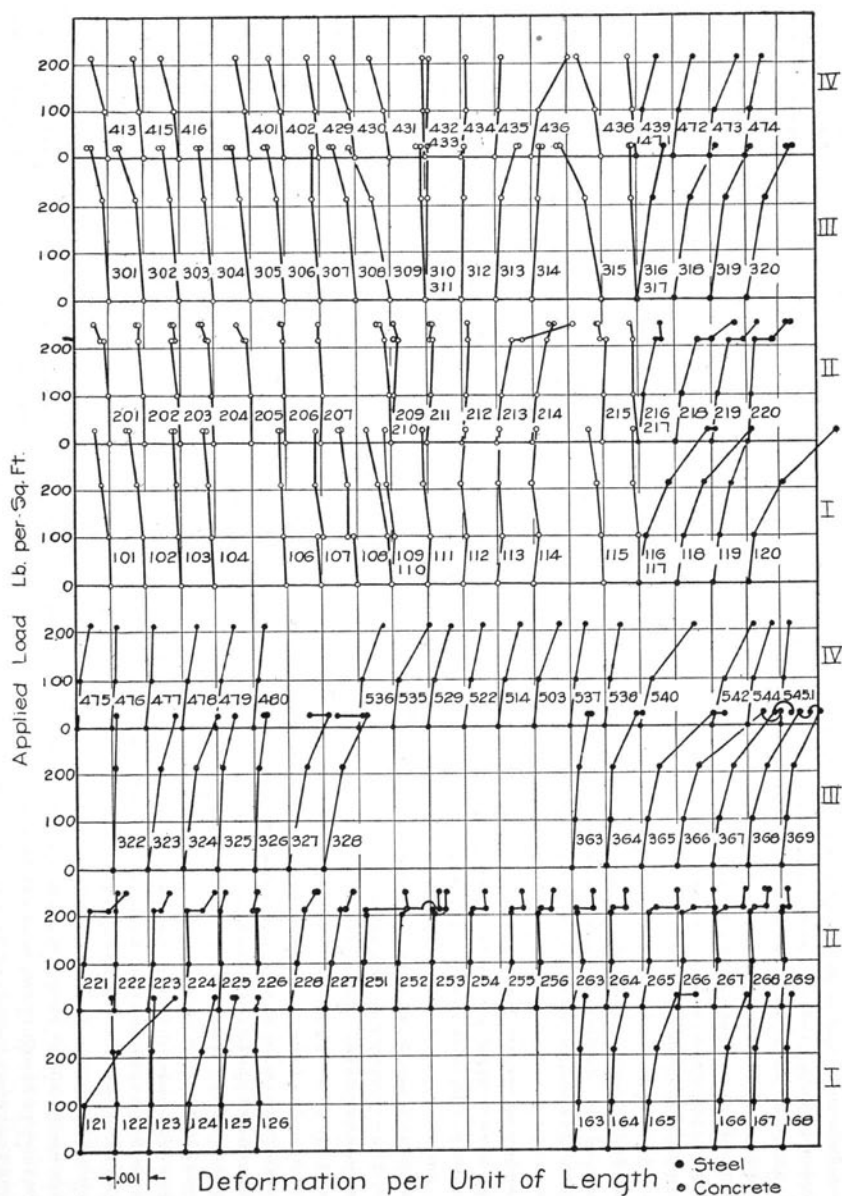
FIG. 62. LOAD-DEFORMATION DIAGRAMS ARRANGED FOR COMPARISON OF GROUPS IN WORCESTER TEST FLOOR

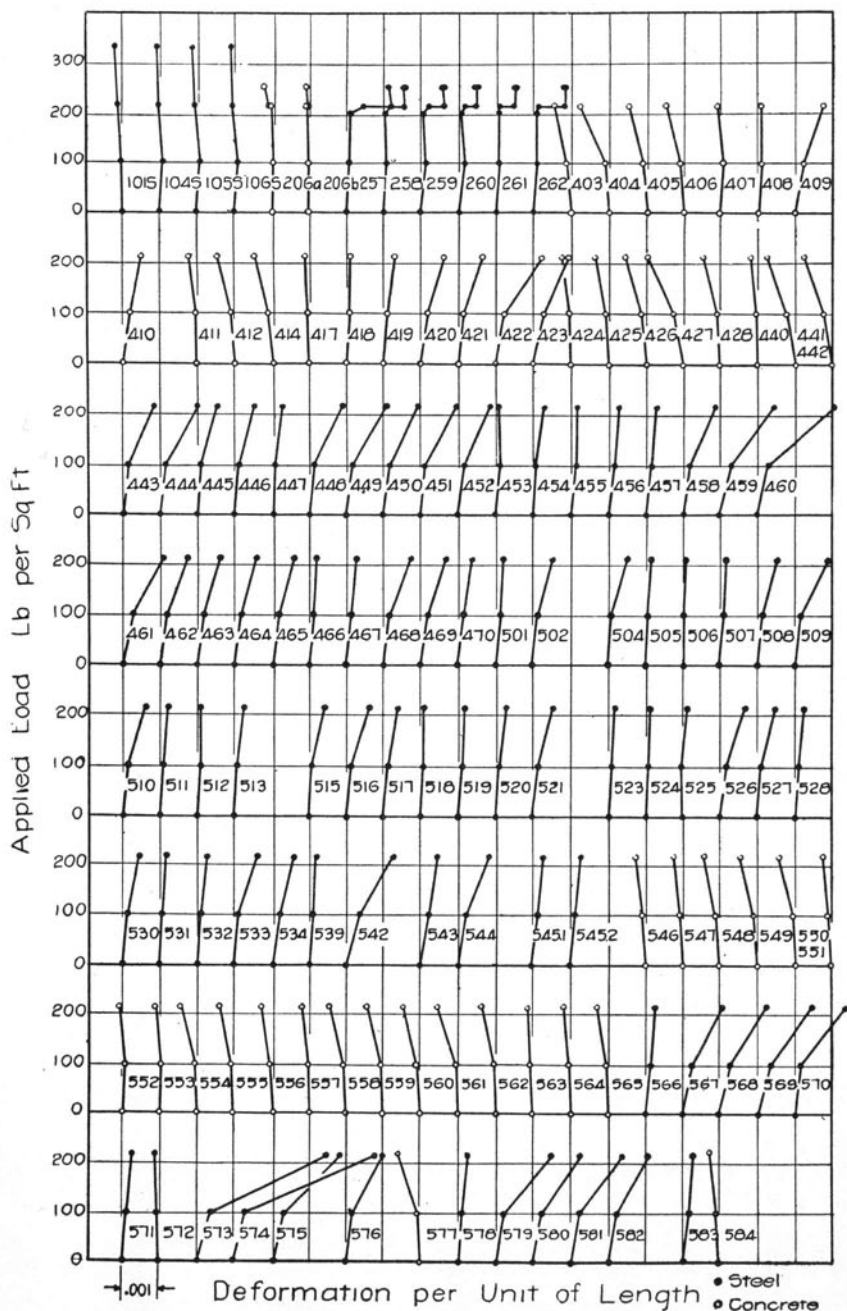
FIG. 63. ADDITIONAL LOAD-DEFORMATION DIAGRAMS FOR GAGE LINES OF WORCESTER TEST FLOOR.

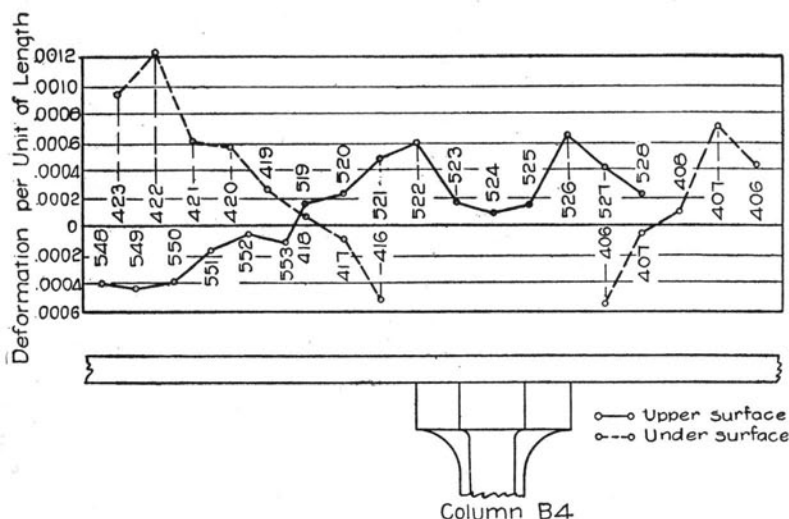
FIG. 64 LOCATION OF POINTS OF ZERO UNIT-DEFORMATION FOR UPPER AND UNDER SURFACES IN GROUP IV OF WORCESTER TEST FLOOR.

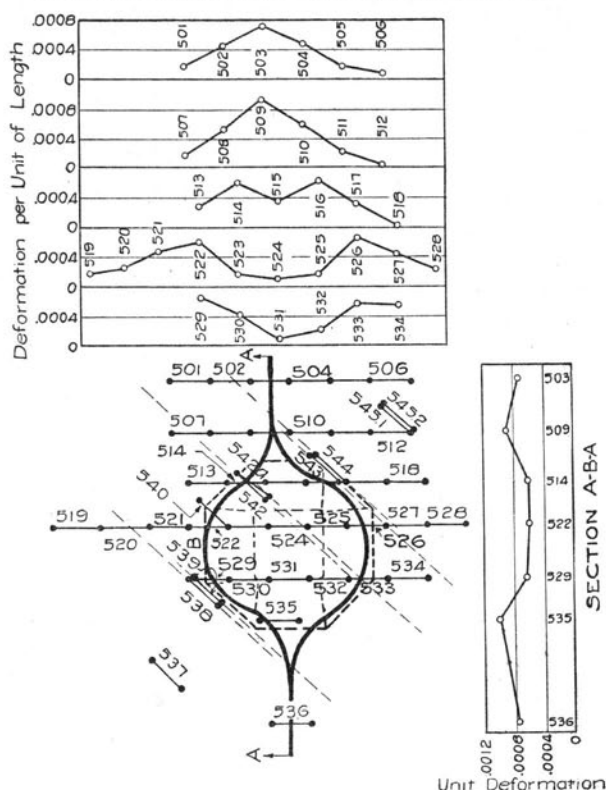
FIG. 65. LOCUS OF POINTS OF HIGHEST STRESS IN A RECTANGULAR BAND OF REINFORCEMENT IN TOP OF SLAB AT COLUMN D4, OF WORCESTER TEST STRUCTURE.

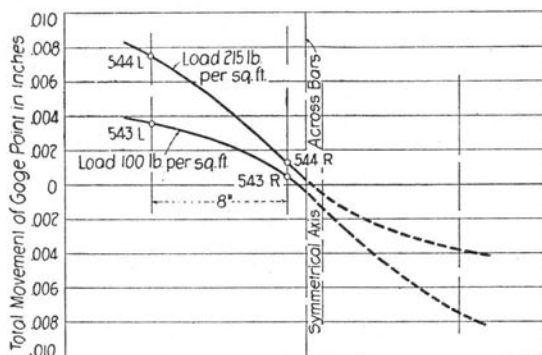
FIG. 71. DIAGRAM INDICATING SLIP OF BARS AT GAGE LINES 533 AND 534 IN WORCESTER TEST FLOOR.

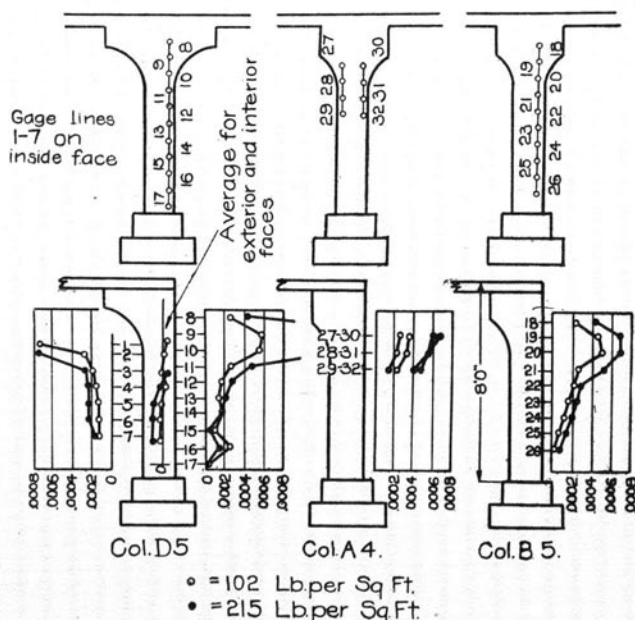
FIG. 72. DIAGRAM SHOWING DEFORMATIONS IN COLUMNS A4, B5, AND D5 OF WORCESTER TEST STRUCTURE.

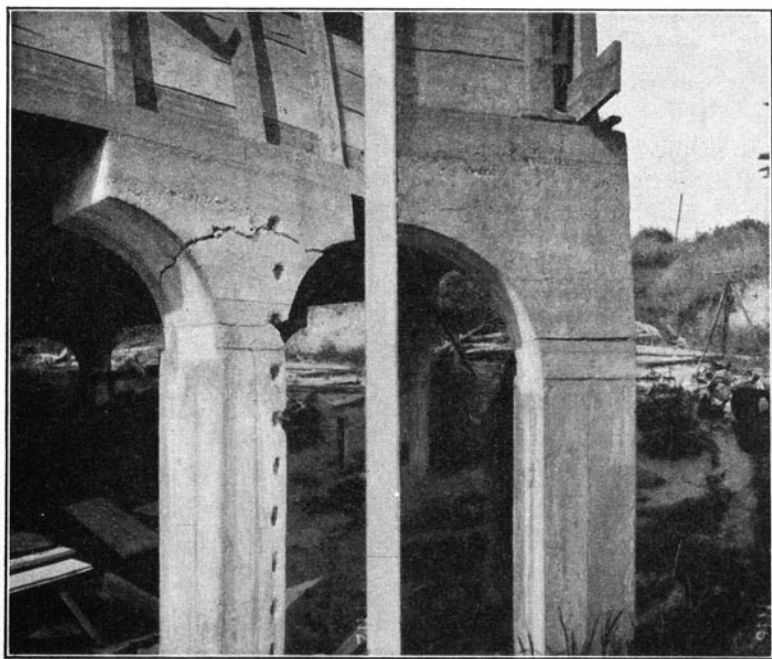
FIG. 73. VIEW OF COLUMNS D5 AND E5 OF WORCESTER TEST STRUCTURE WITH MAXIMUM LOAD IN POSITION.

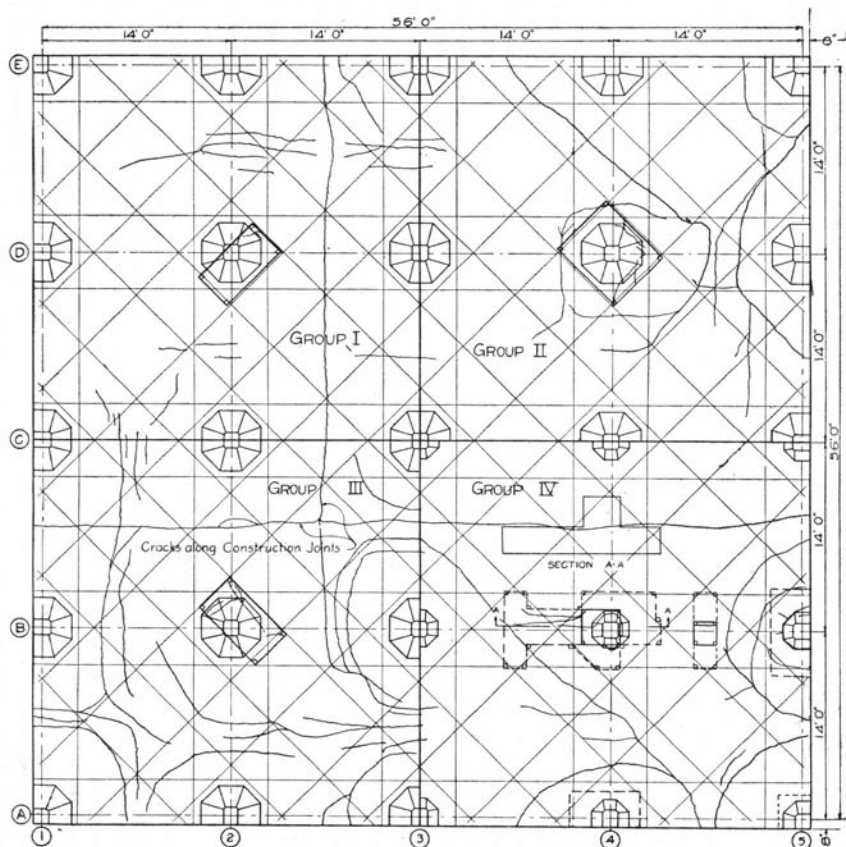
FIG. 74. CRACKS FOUND ON UNDER AND UPPER SURFACES OF WORCESTER TEST FLOOR AT MAXIMUM LOAD.

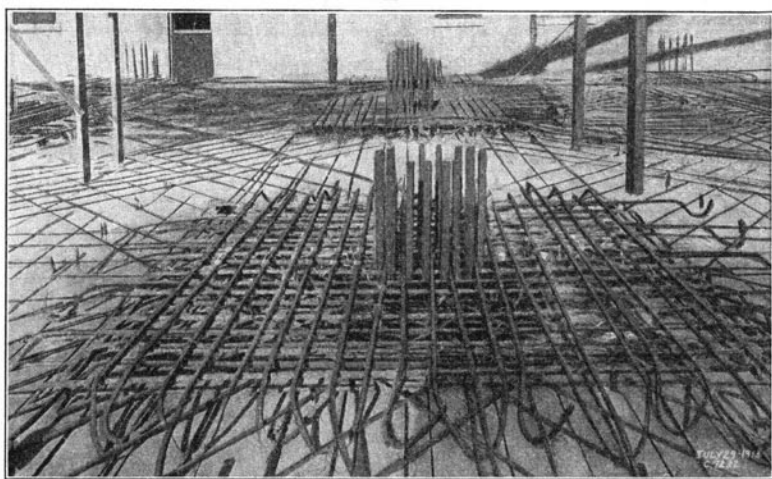
FIG. 75. VIEW SHOWING SLAB REINFORCEMENT IN PLACE IN TEST FLOOR OF CURTIS-LEGER COMPANY BUILDING.

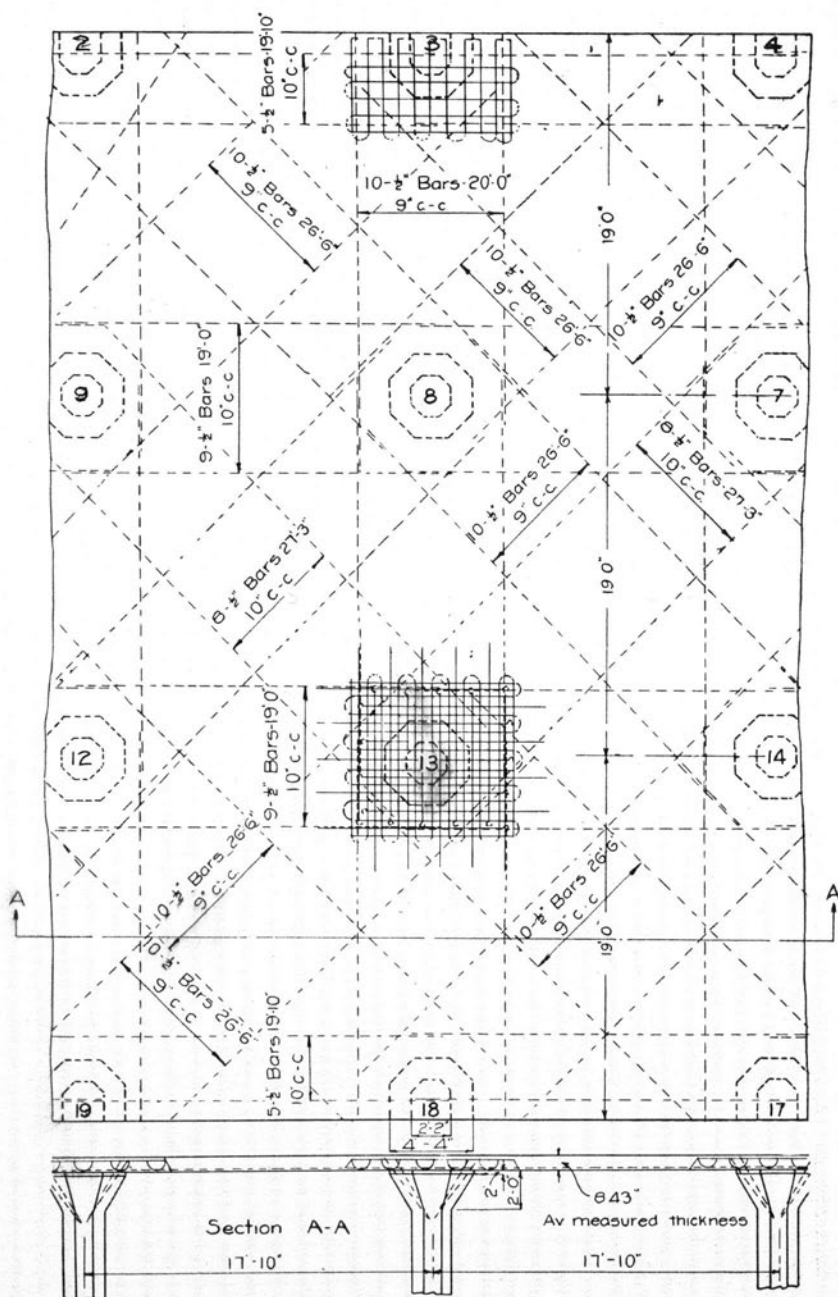
FIG. 76. PLAN SHOWING DIMENSIONS AND REINFORCEMENT OF TEST FLOOR OF CURTIS-LEDGER COMPANY BUILDING.

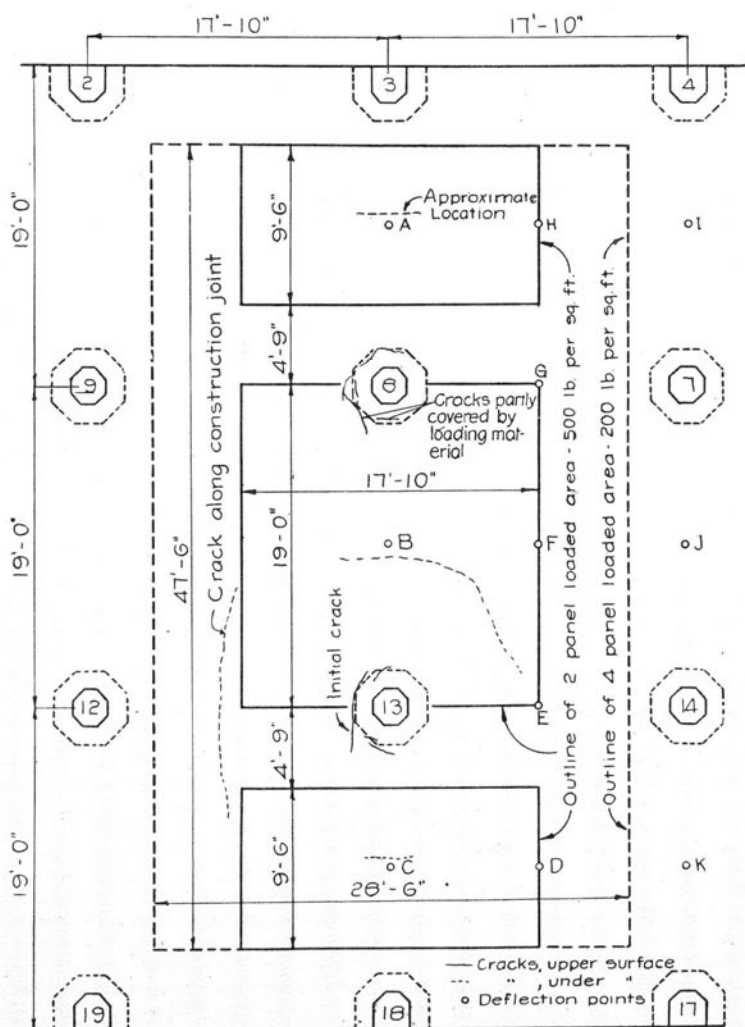
FIG. 77. PLAN INDICATING DISPOSITION OF LOAD AND LOCATION OF DEFLECTION POINTS ON TEST FLOOR OF CURTIS-LEGER COMPANY BUILDING.
